John F Hunt Ltd ENVIRONMENTAL

The Curve, William Street, Slough

Client	Morgan Sindall
Programme	2 weeks
Value	£60,000

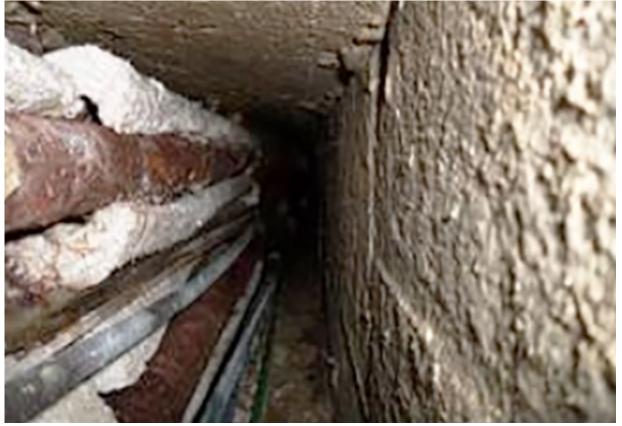
Works were carried out under fully controlled conditions within enclosures which were robust enough to withstand all weather conditions. Pre-fabricated scaffolding was used to build a secure structure along the length of the duct.

Once all isolations had been carried out, the pipes were wrapped in polythene and cut into manageable lengths within the constraints of the sealed enclosure. This allowed the pipe work to be removed with the majority of the asbestos insulation intact, with the minimum of disturbance consequently the potential for fibre generation was much reduced.
